Manandhar, V., Shrestha, H., Marasini, N. P., Prajapati, R., Guragain, R., Chaulagain, R., Sextos, A., Alexander, N. A., De Luca, F., & Giordano, N. (2020). *EXPERIMENTAL INVESTIGATION OF LOW COST STEEL WIRE MESH RETROFIT FOR STONE MASONRY IN MUD MORTAR*. Paper presented at 17th World Conference on Earthquake Engineering, Sendai, Japan.

EXPERIMENTAL INVESTIGATION OF LOW COST STEEL WIRE MESH RETROFIT FOR STONE MASONRY IN MUD MORTAR

Keywords: Stone in Mud Mortar; Retrofitting; Locally available materials; Cost Effective techniques

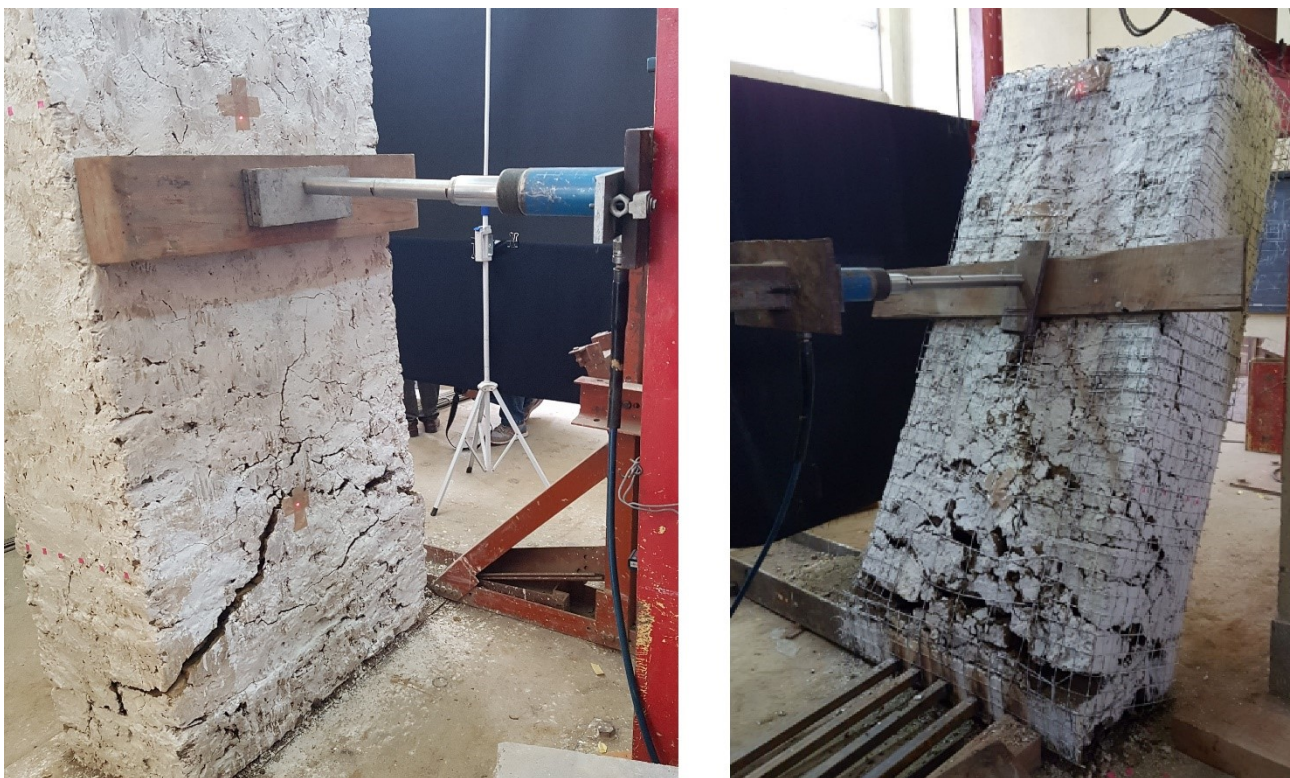
Figure 5 Damage Pattern on the unretrofitted (left) and retrofitted (right) wall

For the unretrofitted wall, the first observable crack appeared at a height of 0.33m at a top deflection of 49 mm. The crack propagated to form a peak shape across the length of the wall on the tension side (refer Figure 5). The damage suffered was highly localized to the region. Due to the limitation of the arm length of the hydraulic jack, the test had to be halted momentarily at multiple occasions when the arm had to be replaced with successive longer ones. At these points, the wall experienced unloading. The wall failed after suffering a maximum top deflection of 321mm at 4.07 KN.

For the retrofitted wall, cracks were more distributed throughout the lower half of the wall. The first observable crack occurred at a top displacement of 67mm. Collapse of the wall finally occurred due to the failure of the bottom GI wires spaced at 150mm spacing along with the vertical wires of splints. The final top deflection suffered before collapse was significantly improved to a value of 769mm at 7.27 KN. These load values were calculated after correcting the error from the analog dial using a digital load cell. Therefore, the absolute value may not be reliable although the figures give a good idea of the relative enhancement in strength.

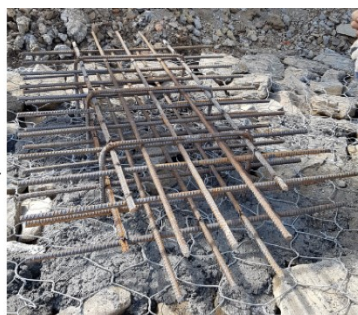
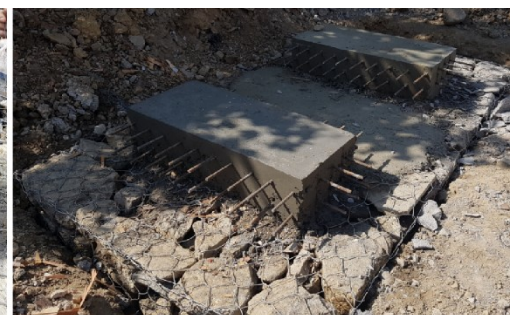
Figure 7 Cross section of the RC pedestal (left); Laid rebar before casting (mid); Casted RC Pedestals (right)

A 400mm thick raft-like stone foundation was constructed that prevented any kind of uplifting. Two M20 RC pedestals were designed to serve as a base for each wall. Multiple protruding rebar were left out for the wire mesh to be connected. The transverse U shaped rebar of the pedestal were continued to the base of the foundation and anchored with 100mm thick M20 concrete (refer Figure 7).

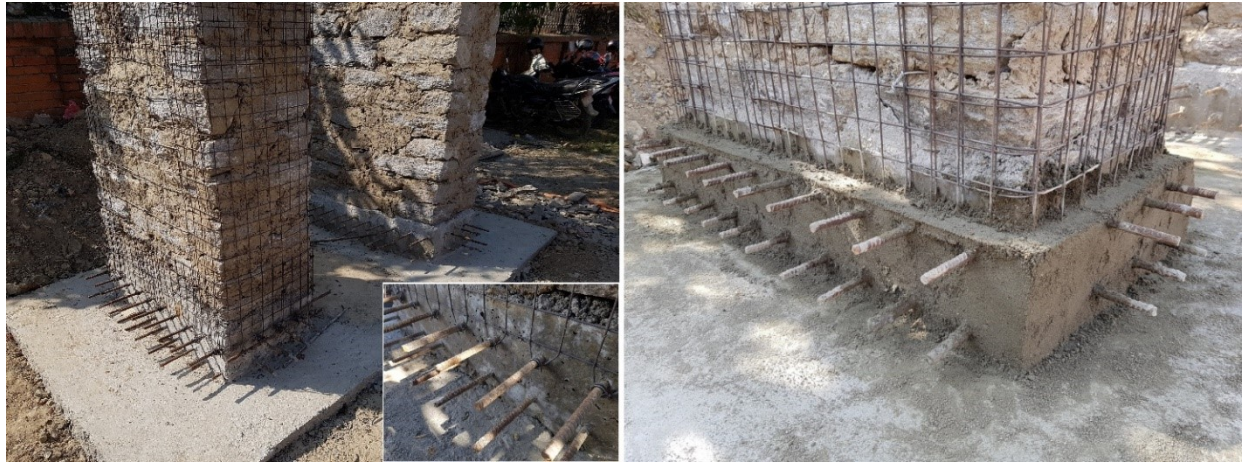
Figure 8 Wire mesh tied and welded to the rebar of the pedestal (left); Connections covered with 50mm of 1:6 plaster (right)

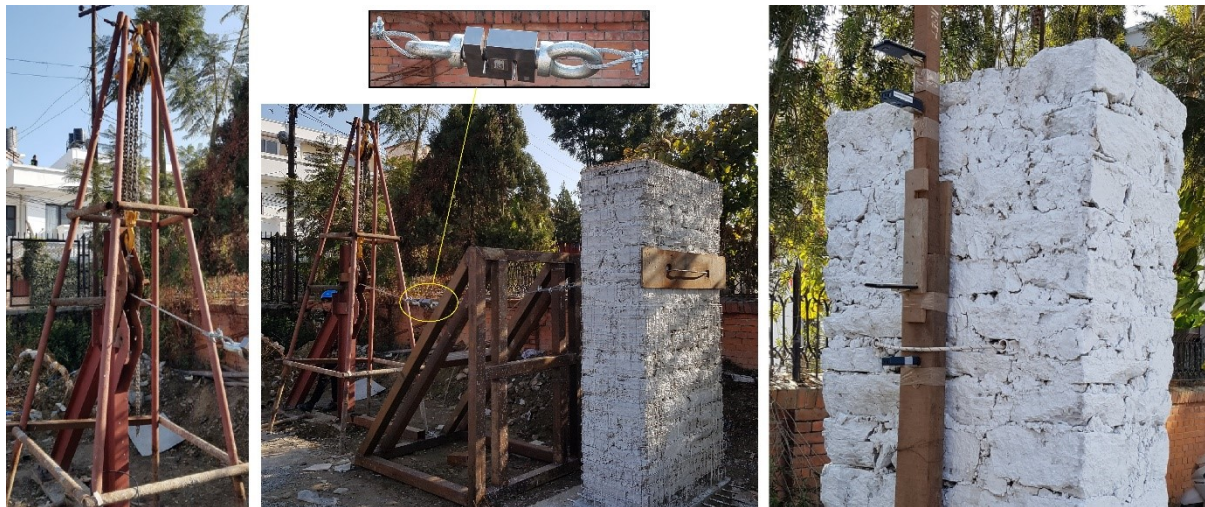
Figure 9 Chain pulley arrangement (left); Pulldown setup for retrofitted wall (mid); Lasers placed pointing towards the retrofitted wall, using the unretrofitted wall as support (right)

A support frame was placed beside the retrofitted wall catering to the need of protecting the load cell and due to safety concerns. Learning from the pilot test, it was anticipated that the retrofitted wall would fail as a unit instead of disintegrating into smaller chunks. Therefore, the need for the support frame was realized. The distance of the support frame was carefully selected so that the retrofitted wall rested on the frame only after suffering complete failure.

High strength steel cables of 10mm diameter were used for pulling, forming loops through and around the walls and around the eye bolt ends of the load cell. The chain pulley was setup in such a way that the upward movement of the hook end would be translated to a horizontal pulling movement via a grooved wheel, connected to the reaction frame (also refer Figure 6). The chain pulley was operated by hand by a technician under the supervision of a structural engineer to maintain a uniform rate of displacement. The least count of the load cell was 0.01KN and that of the laser was 1mm. The test walls were painted white for better visibility of the cracks.
